TECHNICAL MEMORANDUM

**PEDESTRIAN SAFETY REVIEW
PELHAM HIGH SCHOOL TO GLOVER FIELD**

**TRC RAYMOND KEYES ASSOCIATES
A TRC Company
Hawthorne, New York**

September 18, 2003

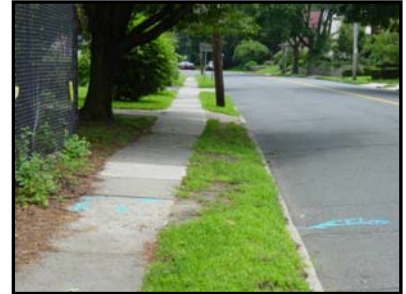
Figure 1

- North side of Colonial Avenue from the High School to Wolfs Lane (Figure 1)

Sidewalk Width- 4 feet

Grass Strip Width- 2 feet

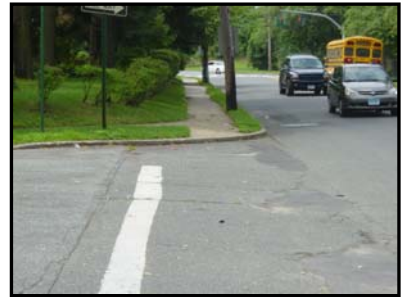
Figure 2

- South side of Colonial Avenue from Stellar Lane to Wolfs Lane (Figure 2)

Sidewalk Width- 4 feet

Grass Strip Width- 2 to 3 feet

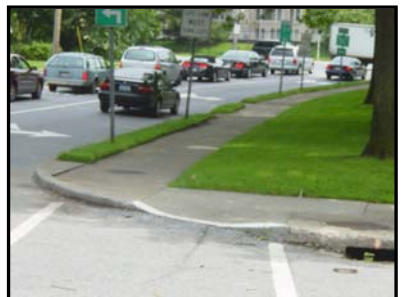
Figure 3

- South side of Colonial Avenue from the Wolfs Lane to Carol Place (Figure 3). (Note- Carol Place will be closed and the sidewalks connected)

Sidewalk Width- 5 feet

Grass Strip Width- 2 to 3 feet

It is TRC’s understanding that the Village of Pelham Manor is considering closing Carol Place at Colonial Avenue and creating a dead end at the library driveway. This would allow extending the sidewalk across the existing road. This would eliminate the crosswalk and eliminate potential conflicts between vehicles and pedestrians.

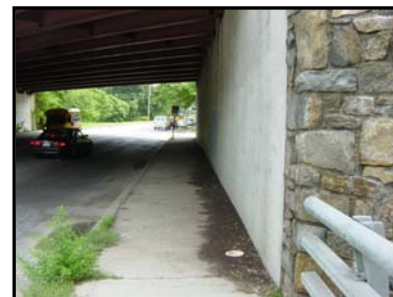
Figure 4

- South side of Colonial Avenue under Hutchinson River Parkway Bridge (Figure 4)

Sidewalk Width- 7 feet 9 inches

The sidewalk area from Carol Place to the west side of the Hutchinson River does not have a buffer zone. The existing sidewalk will allow maintaining a 5 feet wide sidewalk and having approximately 2 feet 6 inches of area to provide a buffer zone. Under the bridge, a significant problem is the trash, dirt and bird droppings that accumulate along the wall (see Figure 4). This reduces the effective width of the sidewalk and forces pedestrians closer to the road. TRC recommends that a program to regularly clean this sidewalk should be implemented along with working with the New York State Department of Transportation (NYSDOT) to determine if netting or another system could be placed under the bridge to discourage birds from sitting and nesting over the sidewalk.

It is not practical to provide a grass strip under the bridge, however, a buffer zone consisting of an alternate pavement material, such as brick or textured concrete, could be installed. It appears that the concrete sidewalk on the bridge over the river may be constructed as a monolithic slab with the bridge. This would require more extensive construction to install the buffer strip on the bridge. The buffer zone has the advantage of delineating the five feet wide concrete walk and encouraging pedestrians to walk away from the road; however, it would not prohibit pedestrians from walking adjacent to the road.

It is TRC's opinion that providing a buffer zone in this area would alert pedestrians to stay in the sidewalk, away from the curb. The cleaning and elimination of the debris and bird dropping condition under the bridge is crucial to making this effective. A barrier does not appear to be necessary to assure pedestrian safety. Considering the disadvantages of the various types of barriers, TRC does not recommend a barrier.

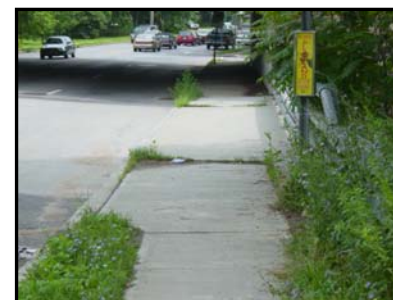
Figure 5

- South side of Sanford Boulevard over Hutchinson River (Figure 5)

Sidewalk Width- 7 feet 8 inches

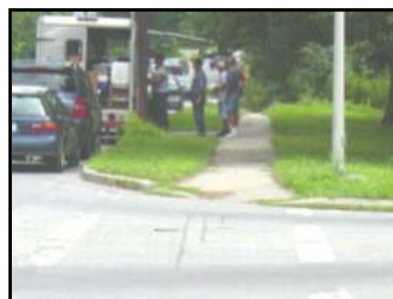
Figure 6

- South Side of Sanford Boulevard Avenue from the Hutchison River Bridge to the Hutchinson River Parkway Ramp (Figure 6)

Sidewalk Width- 4 feet

Grass Strip Width- 6 feet

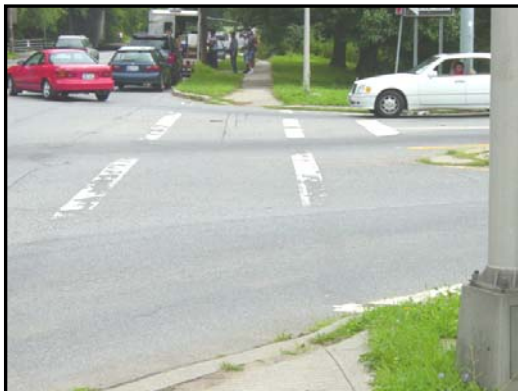
Figure 7

There is a cross walk at the end of the Hutchinson River Parkway Southbound Ramp. This signalized intersection does not have pedestrian buttons. The “WALK” cycle occurs every 55 to 60 seconds. The walk remains for approximately 10 seconds. The pedestrian signals do not have “DON’T WALK” indications to warn the end of the cycle. The crosswalk at the intersection is poorly marked (Figure 7). Also, TRC was advised that pedestrians walk diagonally across the ramp terminus to enter the park, which creates unsafe conditions (Figure 8)

- Provide pedestrian call buttons on the crosswalks
- Provide proper pedestrian signals on the crosswalks
- Re-stripe the crosswalks
- Install a fence, guiderail or extend the existing concrete barrier on the west side of the southbound ramp to prohibit pedestrians from walking diagonally across the intersection to go toward Glover Field
- Provide “NO TURN ON RED” signs to protect pedestrians in the crosswalks. This includes the Parkway off ramp turning onto Sandford Blvd. eastbound and on Sandford Boulevard eastbound, turning onto the southbound Parkway on ramp

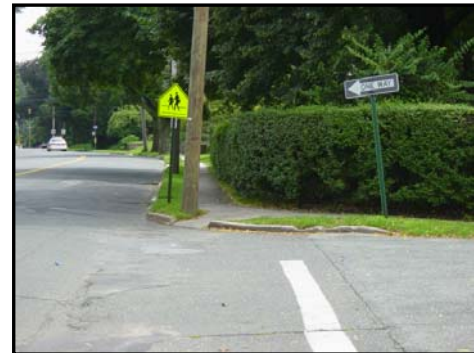
Figure 13

- The existing hedge on the southwest corner of the intersection restricts the vehicle sight distance looking to the east along Colonial Avenue. The sight distance should be analyzed and the Village should consider prohibiting left turns if the condition is found to be unsafe (Figure 13).

- Re-stripe the pedestrian crosswalk across Stellar Avenue and move the stop sign and stop bar to behind the crosswalk (Figure 13 and 14)
- Replace the existing pedestrian ramps if determined they are not in compliance with ADA standards
