Village of Pelham

INSPECTION, TESTING AND ASSESSMENT OF THE Highbrook Avenue New York, Westchester and Boston Railway Bridge

BERGER,
LEHMAN Associates, P.C.
Consulting Engineers
Transportation Planners

February, 2001

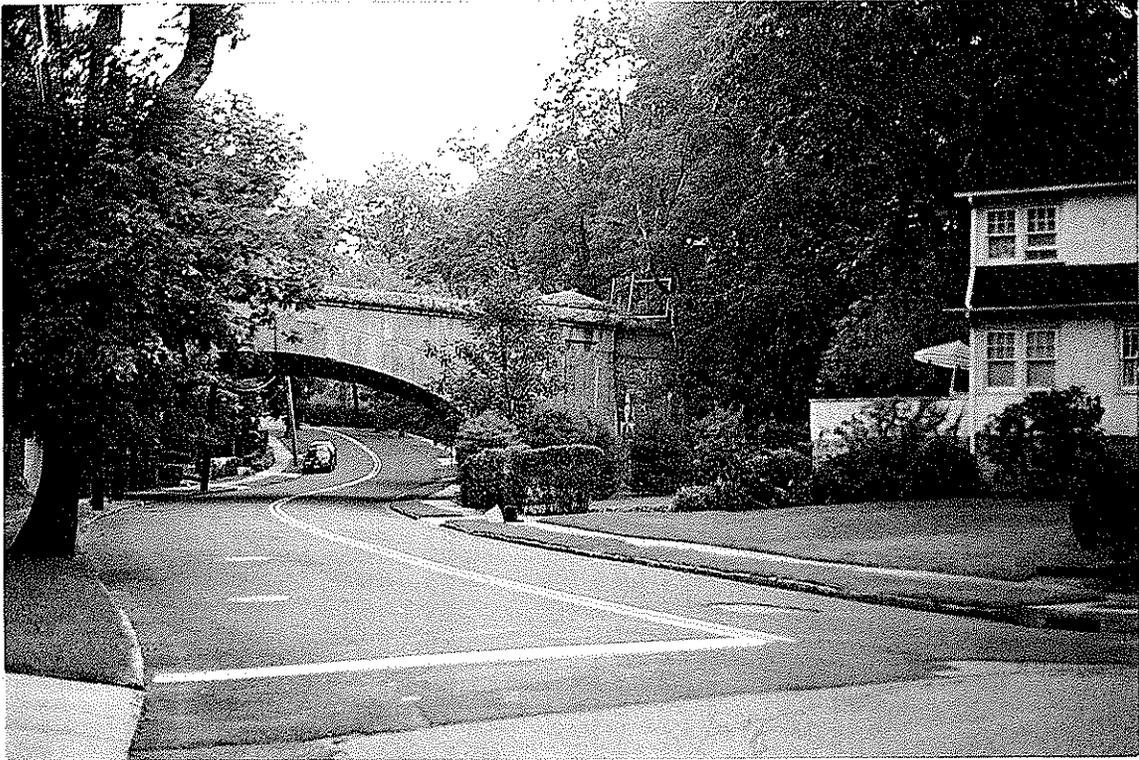
View of Structure from the South

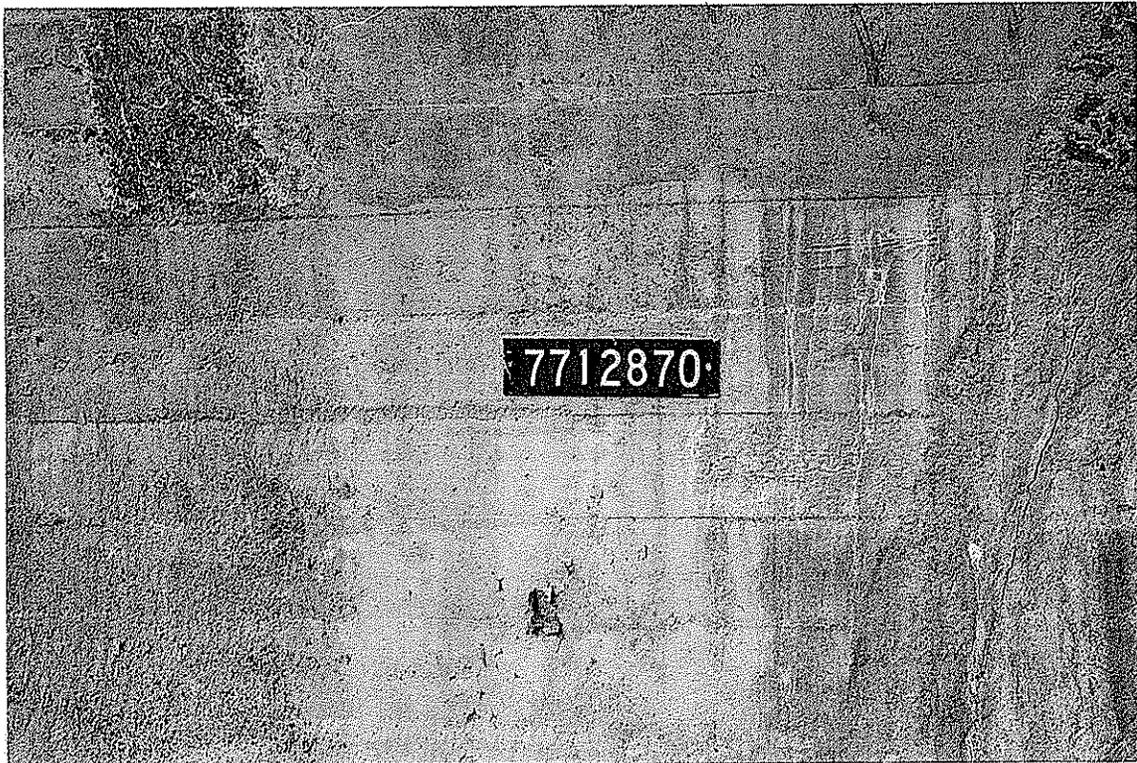
B.I.N. Plate on East Leg of Arch

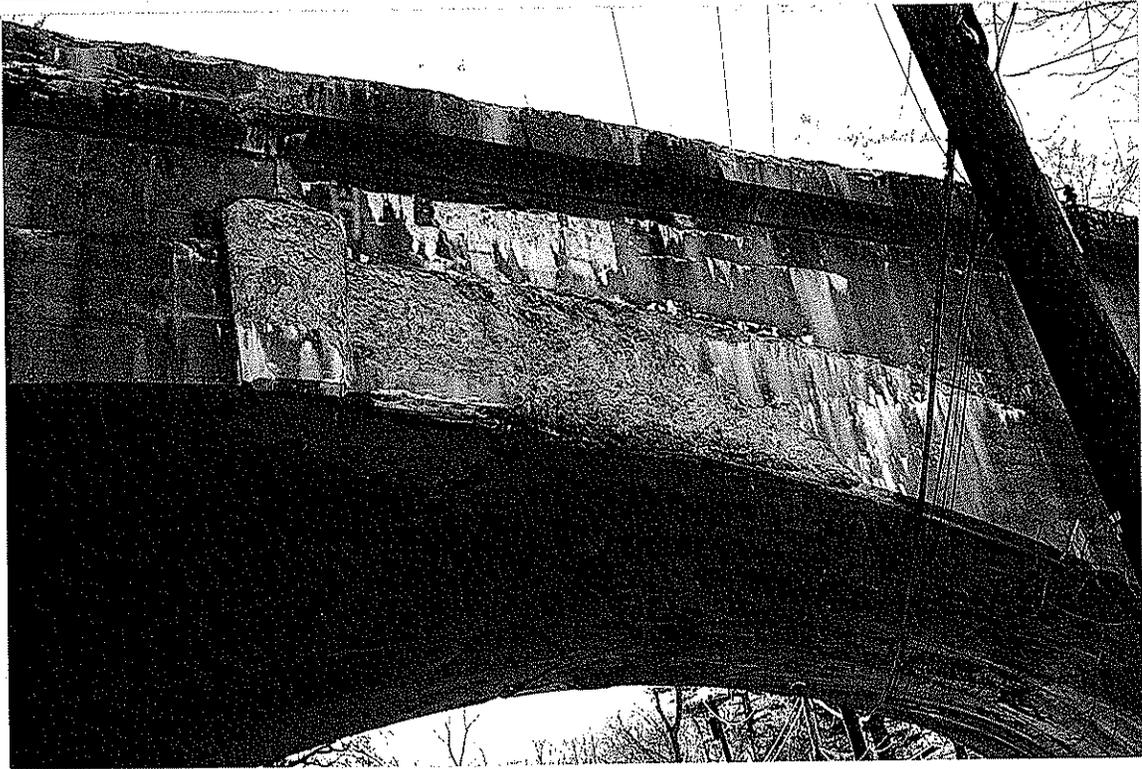
North Fascia

The north face of the arch was noted to be in poor condition. While sounding, this face, a large quantity of concrete which posed a hazard was removed. The area of spalling, delaminations and cracking extended from the emblem at the crown to approximately 20 feet to the west. This area was marked in orange paint for additional removal by Village personnel. Large spalls were noted at the top and the bottom of the north face adjacent to both the east and west wingwall.

A sounding of the north spandrel wall revealed a section of approximately 15 square feet of hollow concrete with accompanying cracks and efflorescence. This area was marked in orange paint for removal. Three other horizontal cracks with efflorescence were noted on the western half of the north spandrel wall. Vines were found on the eastern half of the wall.

Note Delaminating Concrete on North Face of Arch
Note Hollow Areas, Cracks, & Efflorescence on Fascia Wall
Note Orange Paint Indicating Area Recommended for Further
Concrete Removal

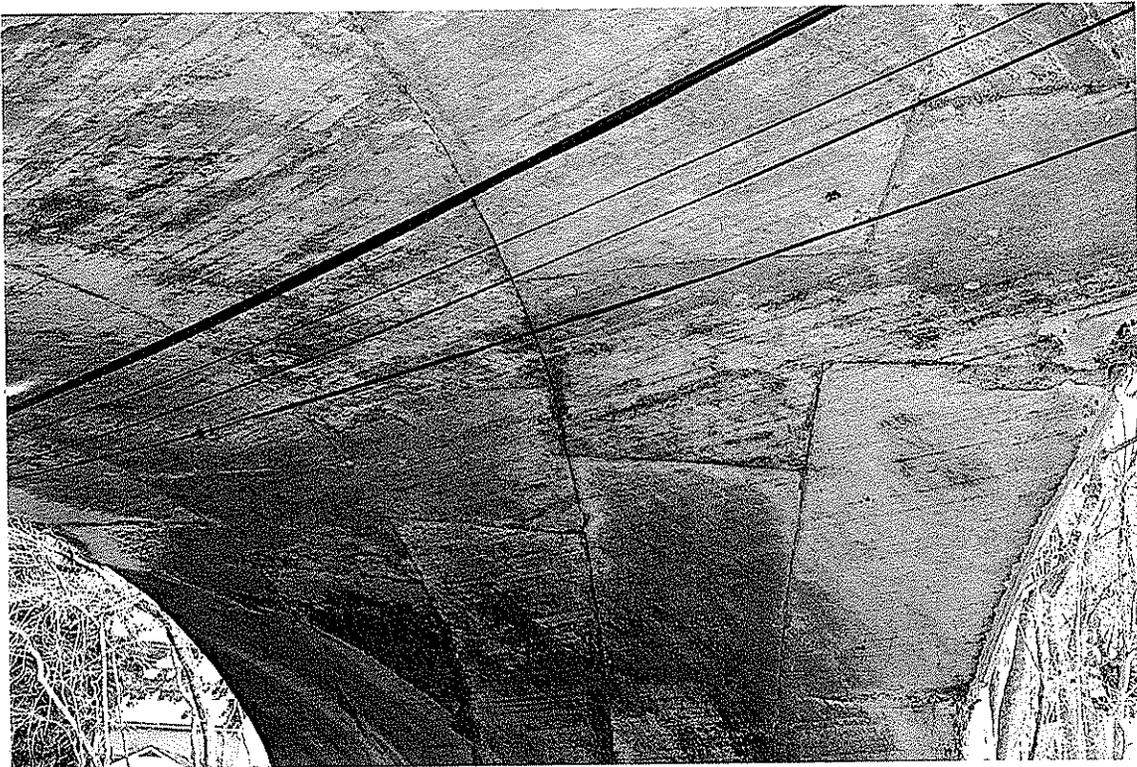
Arch: The arch appeared to be constructed as five separate longitudinal sections with joints between the different sections. In addition each longitudinal section appeared to be constructed

Underside of Arch Looking East

Note Longitudinal and Transverse Construction Joints

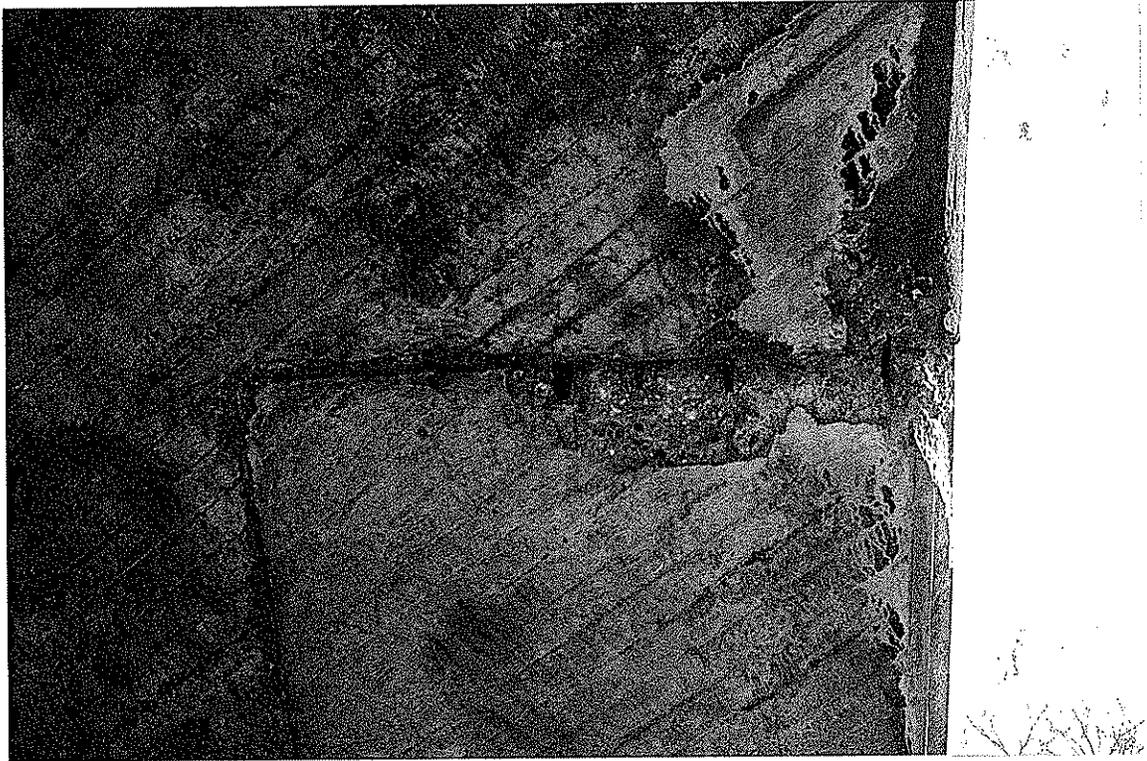
in segments. The underside of the arch was found to be in fair condition. Spalling was found at the apex of the arch at both fascia lines. The spalling revealed steel reinforcing bars. The spalls are adjacent to a transverse joint on the south fascia and encompasses the transverse joint on the north fascia. The spalling at the north side extends along the fascia approximately four to five feet. Two spalls with exposed rusted steel bar were noted on the east side of the underside of the arch at the longitudinal joint between the first and second section and the second and third section from the north. Large areas of patch material were found approximately at the crown of both the second and third section from the north. Adjacent to the patch material is a spalled area. Patch material with adjacent spalling was also noted on the south section on the east side adjacent to the fascia. A small spall was noted on the south section adjacent to the fascia on the west side. A hollow area of approximately two square feet was sounded on the underside of the arch between the third and fourth section towards the west side. Efflorescence, indicating leakage through the joint, was noted between the first and second section at the west side. A small transverse crack with efflorescence was noticed starting at the fourth longitudinal joint extending to the south for approximately two feet.

Underside of Arch at South Fascia
Note Exposed & Rusting Steel Bars

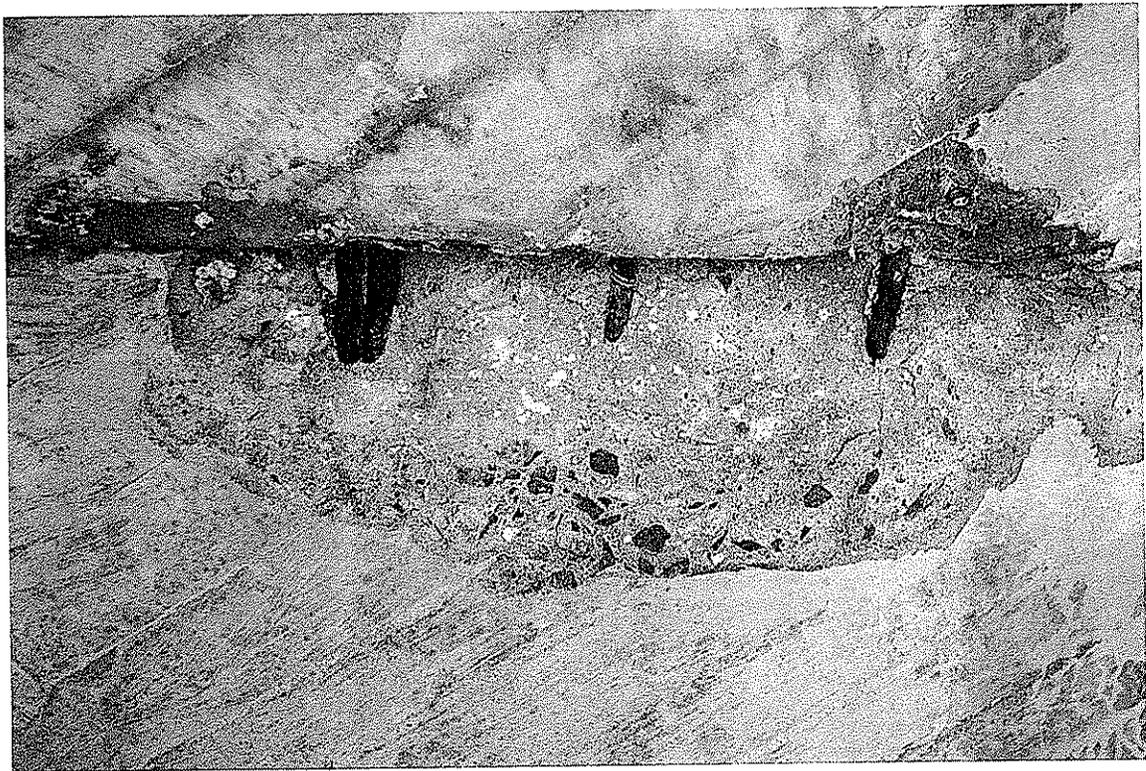
Spall on Underside of Arch with Exposed Steel Bars

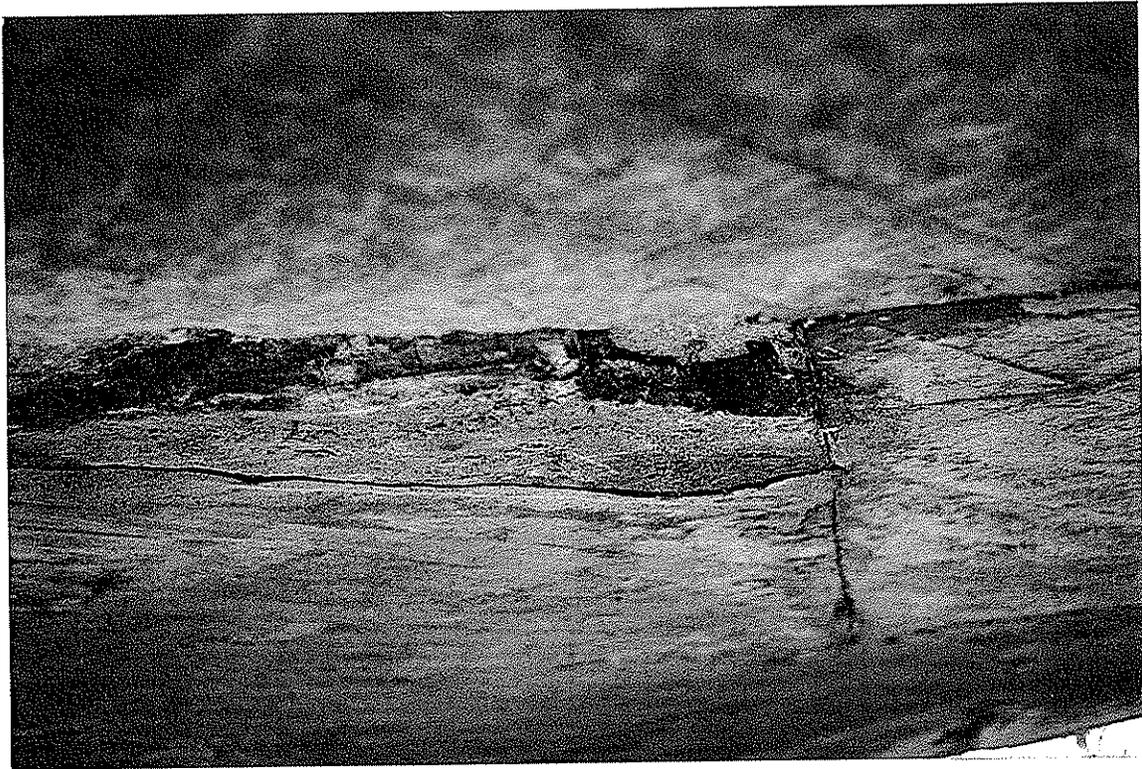
Underside of Arch
Note Separating Concrete
Note Orange Paint Indicating Area Recommended for Further
Concrete Removal

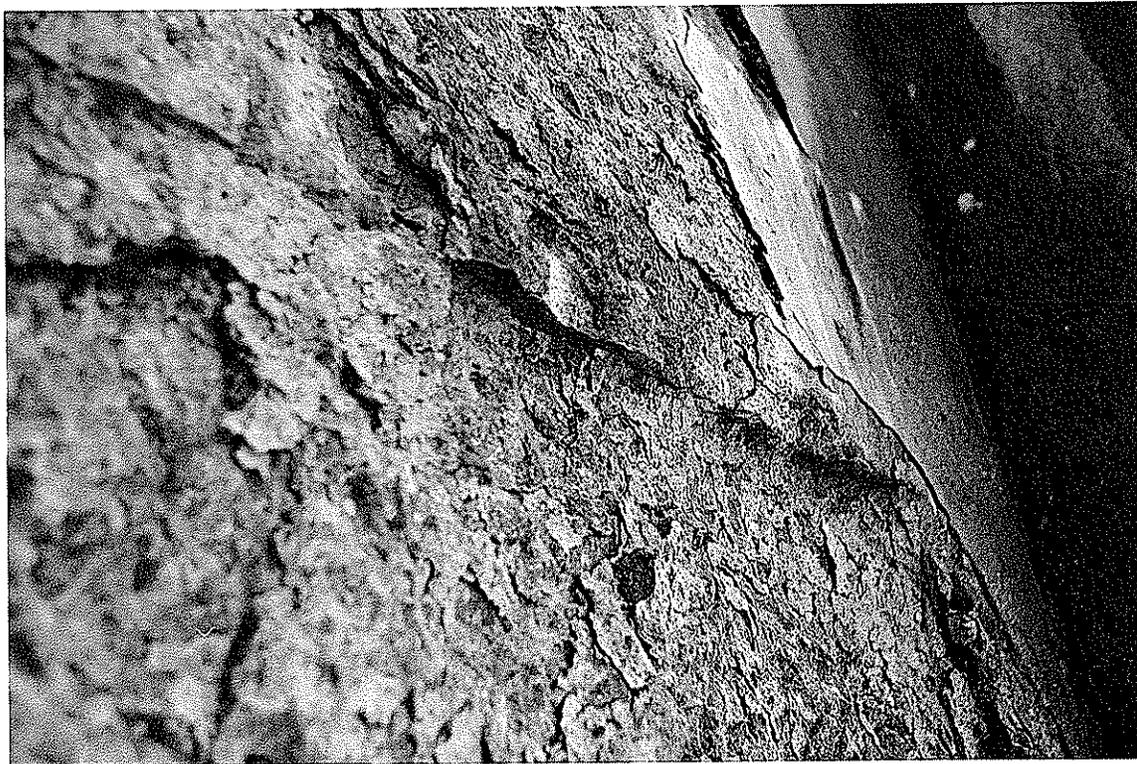
Wingwalls: The wingwalls appear to have been constructed with a thin layer of parging placed over layered mass concrete. The parging was found to be extensively compromised with large areas of it either spalled off, delaminated, or scaled. The underlying concrete appeared to be of much poorer quality than that of the arch. Some of the aggregate in the concrete was noted to be rounded river rocks and mica; both which provide a poor bond to the surrounding cement matrix. There were no indications of reinforcing steel in the wingwall concrete. Where the parging has spalled the underlying concrete was noted to be undergoing extensive deterioration. The concrete is delaminating throughout the exposed areas. A sounding with the hammer found a very soft matrix and easily removed aggregate. The north east wingwall exhibited the greatest deterioration with the loss of concrete estimated to be one foot deep at the top of the wingwall. The parapets, on top of all four wingwalls, were noted to be spalled for the complete length of the wingwalls. The decorative concrete pyramids that top the pilasters were found to be extensively spalled.

Close-up of Typical Wingwall Concrete
Note Delaminating Concrete

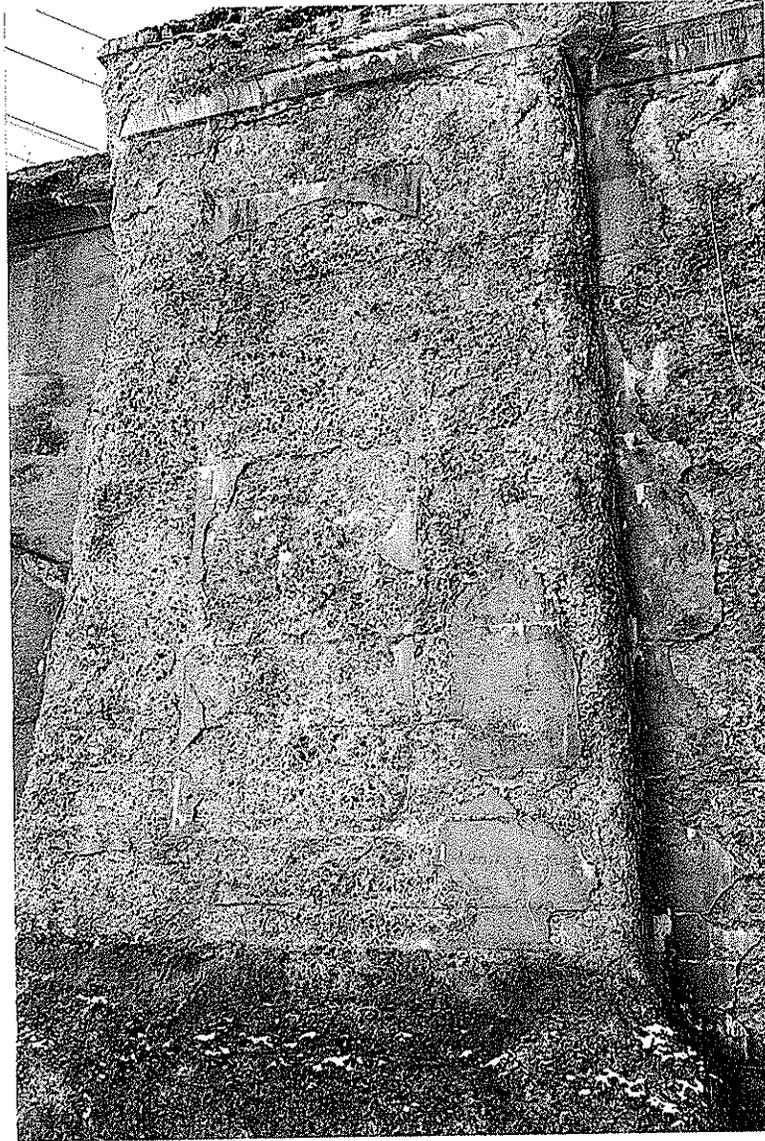
Northwest Wingwall Pilaster- Typical Condition
Note Severely Eroded Concrete

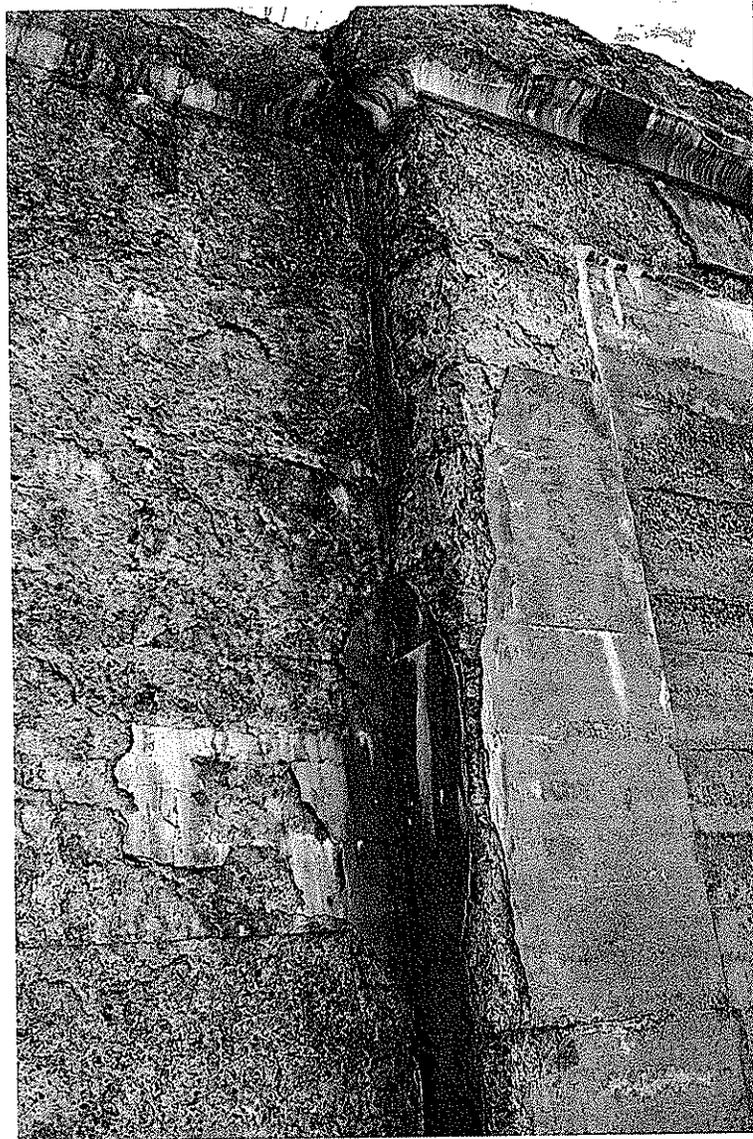
Northeast Wingwall
Note Delaminated Parging and Spalling Concrete

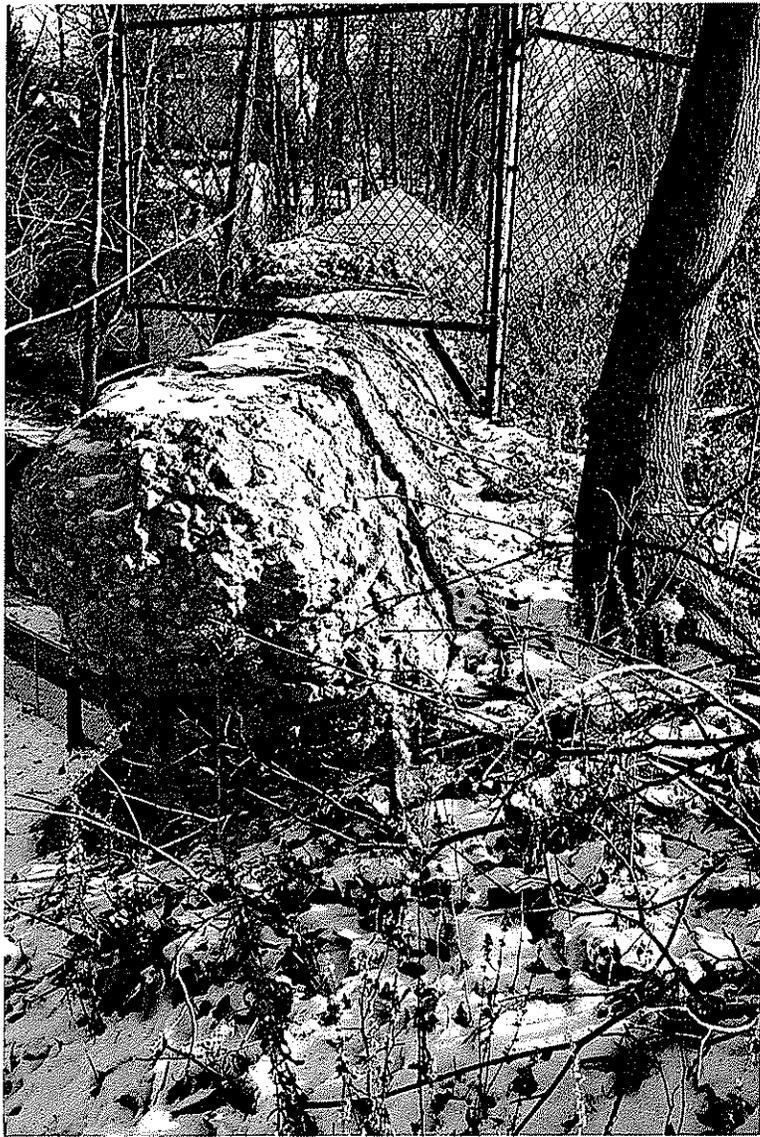
End of Northwest Wingwall with Exposed Parapet
Looking East

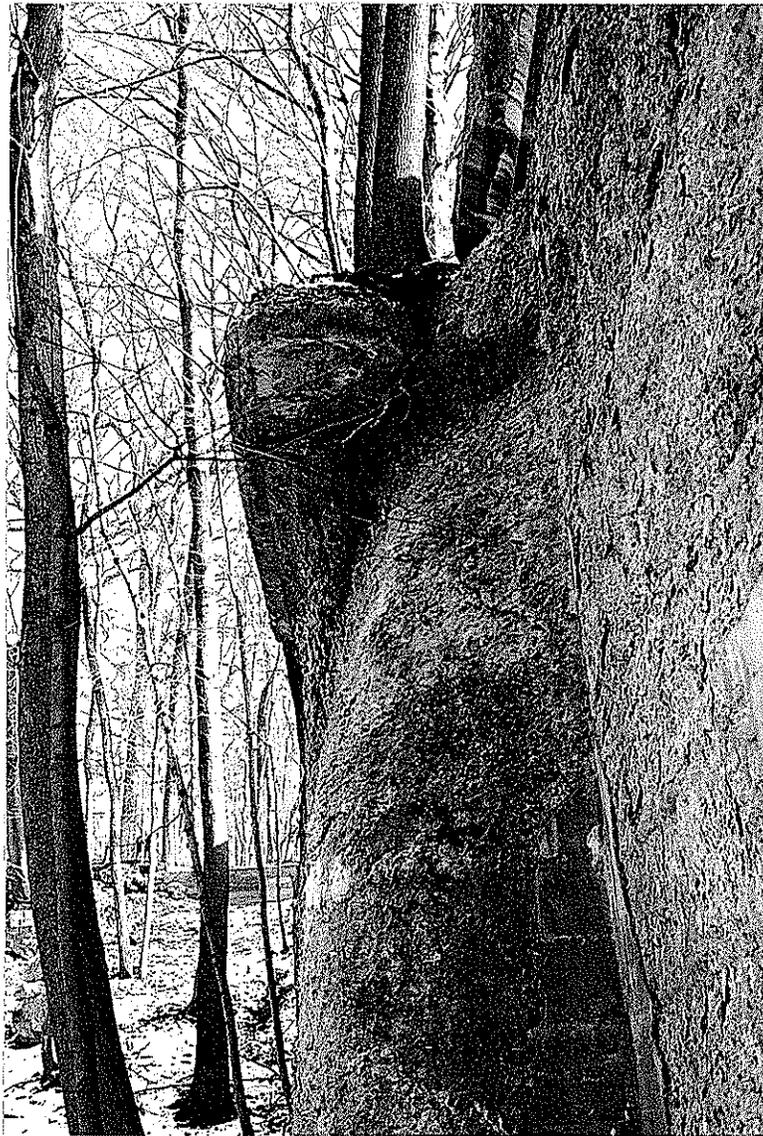
Northeast Retaining Wall
Note Tree Dislocating Coping and Erosion of Concrete

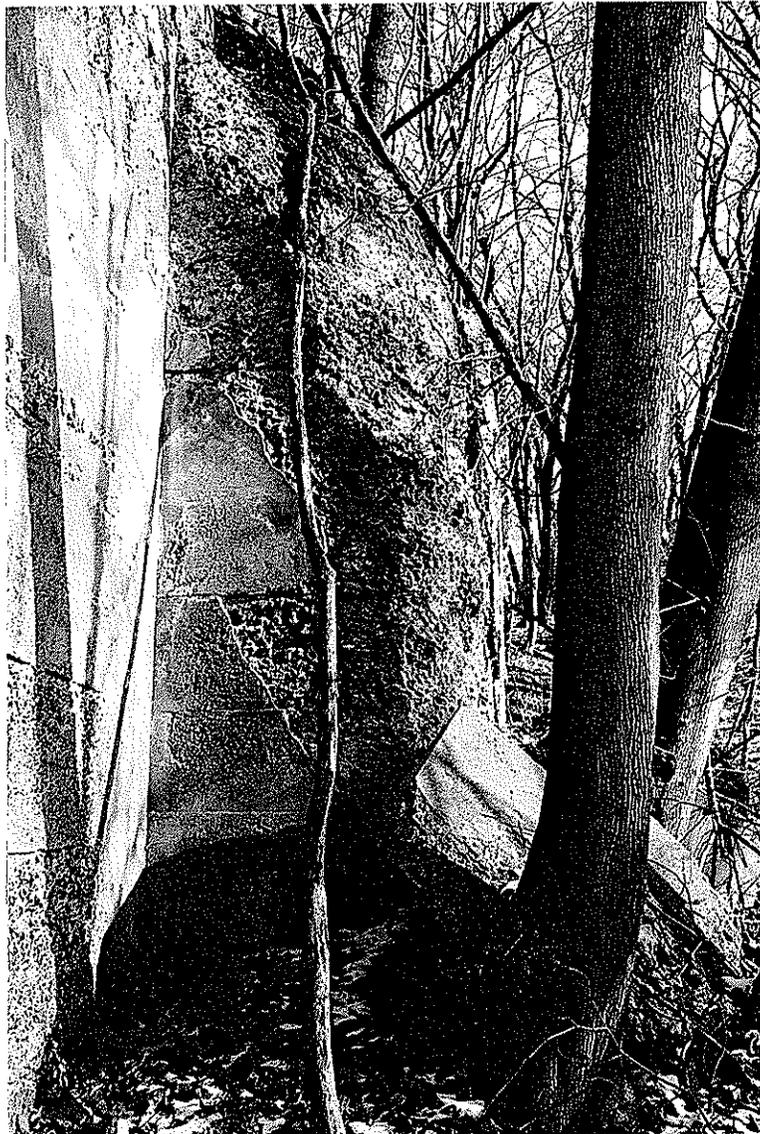
Southeast Retaining Wall
Note Coping on Ground, Loss of Concrete, and Erosion of
Backfill

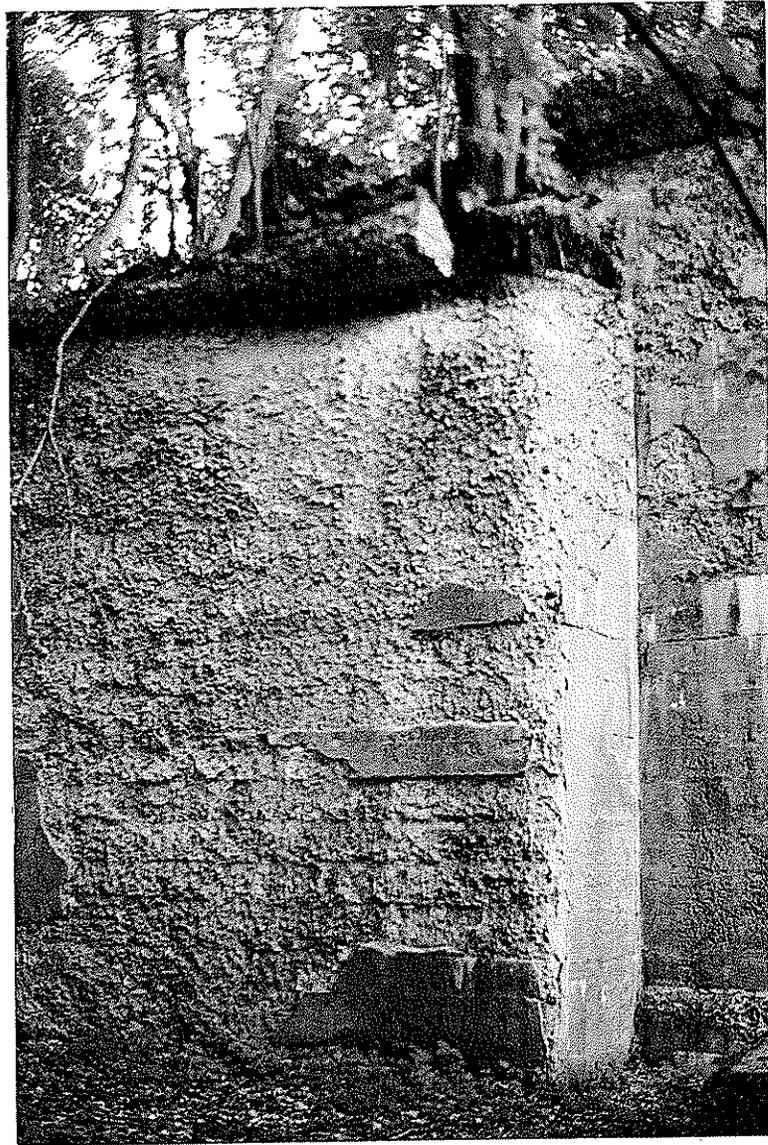
Southwest Retaining Wall
Note Concrete Coping being Dislodged

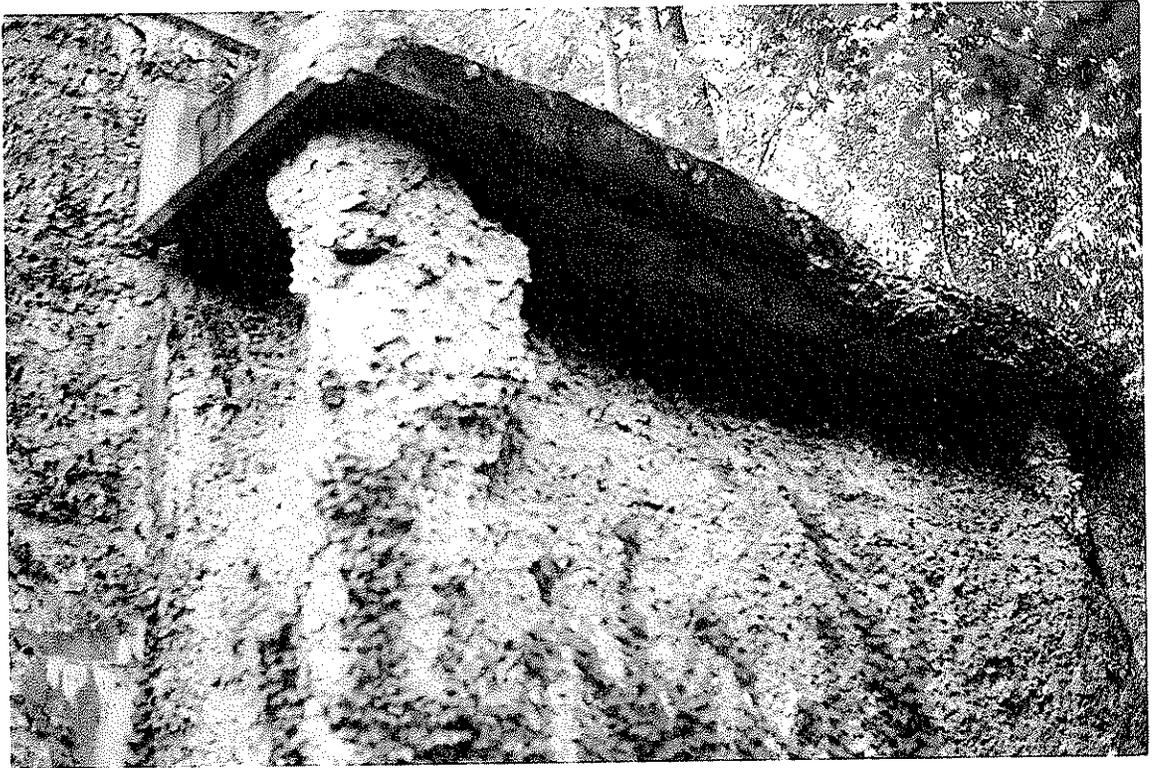
Northwest Retaining Wall- Looking Northwest
Note Compromised Coping and Concrete Loss Estimated at Four Feet

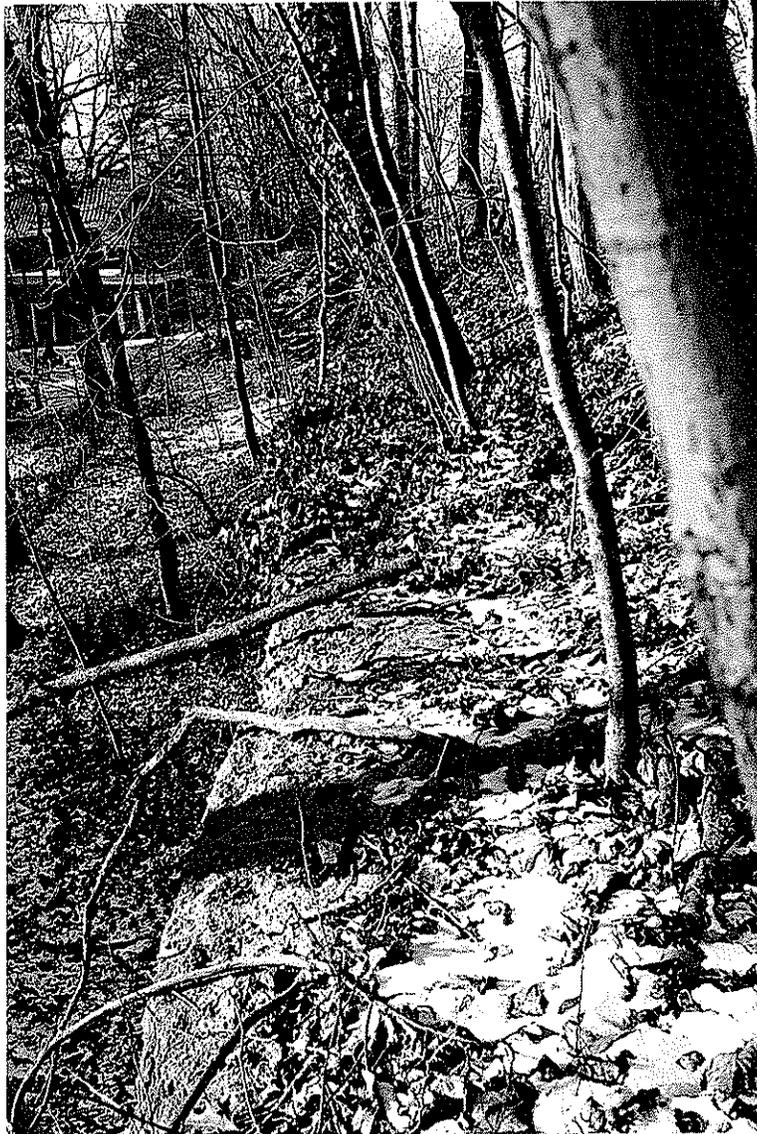
Retaining Walls: The top of the retaining walls were constructed to the top of railway grade and are currently covered with soil and vegetation. There is no fencing or other protection to prevent an accidental fall from the top. Nor is there any delineation visible. This is a potentially hazardous situation. Drainage from the upper grade at the juncture of the retaining walls with the wingwalls is causing extensive deterioration of the wingwalls. Since the retaining walls are built lower than the wingwalls it appears that surface water is being channeled to this juncture and eroding the concrete. At the beginning of both south wingwalls the concrete has been so eroded that the coping (originally on top of the wingwalls) have already fallen. On the northeast side the coping overhangs the eroded concrete by approximately three feet. In addition it is being dislocated by the root of a tree. This coping is in imminent danger of falling and it is recommended that it be removed in a controlled manner. The coping at the start of the northwest retaining wall overhangs the eroded concrete up to an estimated four feet. It is currently being supported by a column of extensively spalled concrete. While the area below this overhanging coping is fenced it is still recommended that it be removed in a controlled manner.

Southwest Retaining Wall - On Top Looking West
Note - No Delineation, Fencing or Other Fall Protection

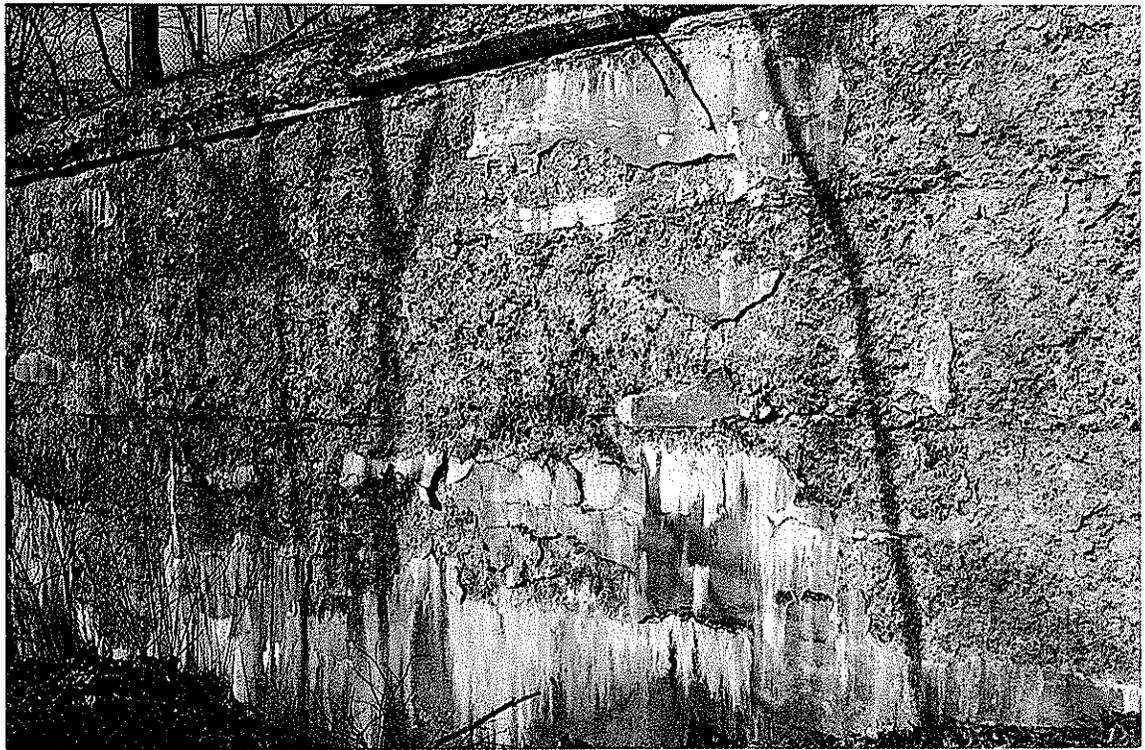
Southwest Retaining Wall- Typical Condition
Note Delaminated Parging, Efflorescence, and Spalling Concrete

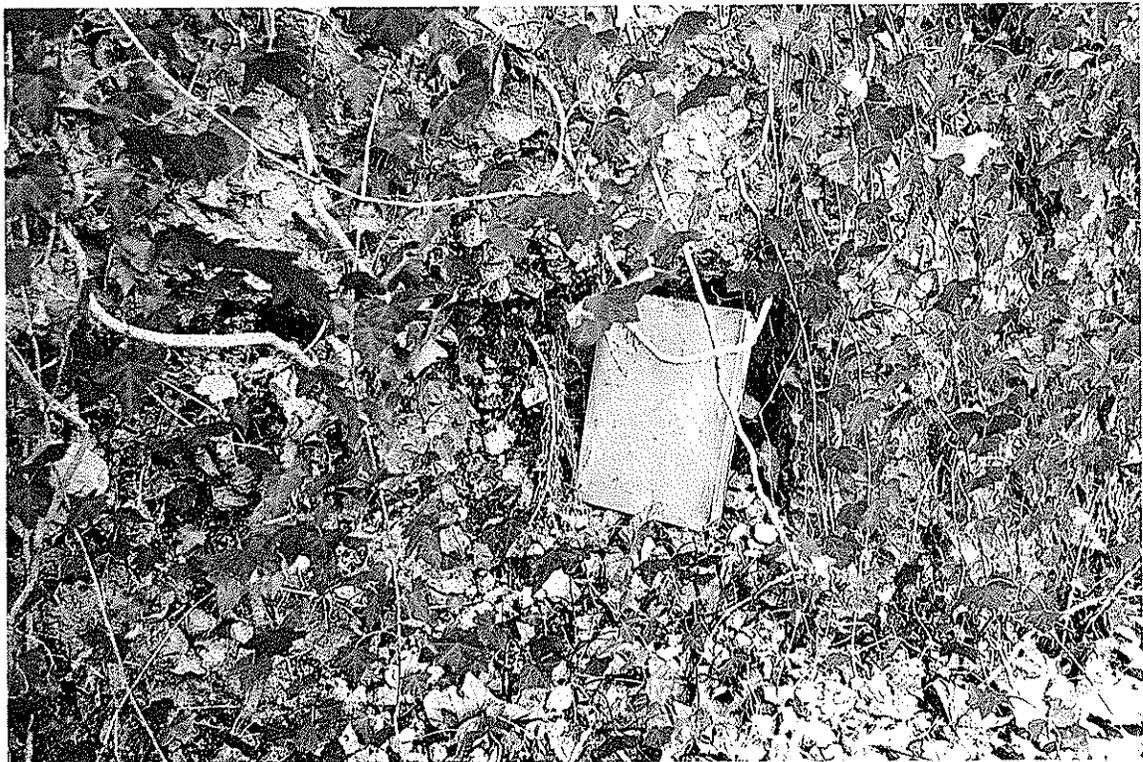
Northwest Retaining Wall- Ivy Covered
Note Up to Two Foot Loss of Concrete at Groundline
Note Continuing Delamination of Concrete
