TECHNICAL MEMORANDUM

**PEDESTRIAN SAFETY REVIEW
PELHAM HIGH SCHOOL TO GLOVER FIELD**

**TRC RAYMOND KEYES ASSOCIATES
A TRC Company
Hawthorne, New York**

September 18, 2003

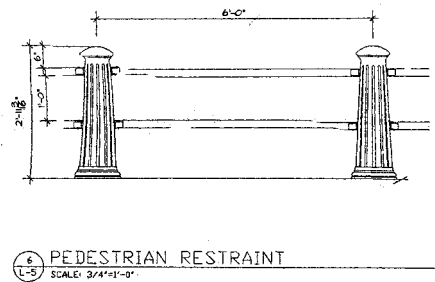
Figure 9

Fences or similar devices are used to channel pedestrians to safe crossing locations. Examples of the use of such devices can be found in New York City, White Plains and New Rochelle. At Iona College in New Rochelle, ornate bollards (six feet on center) with 1-1/2 inch rails between the bollards are being installed along North Avenue to channel pedestrians to a crosswalk (Figure 9) The reconstruction on North Avenue also includes a two-foot wide brick border (buffer strip) adjacent to the road.

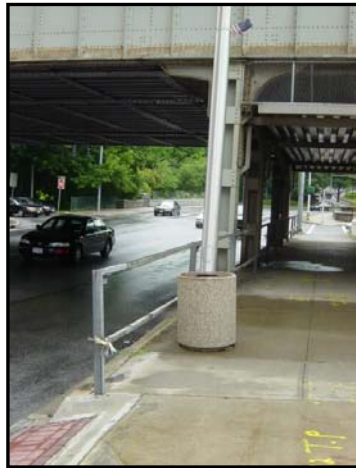
Figure 10

In White Plains, a metal rail has been used near the Westchester Mall and at the train station (Figure 10 and 11). White Plains officials indicated the pedestrian rail near the Westchester Mall (Figure 11) had been hit by vehicles and they subsequently have installed a guiderail in front of the rail to minimize the damage. A pedestrian rail under the Parkway Bridge should be installed 2 feet 3 inches from the face of curb to minimize the potential damage from cars and trucks. This will allow maintaining a 5 feet wide sidewalk behind the rail. A pedestrian rail will make it difficult for pedestrians to walk from the sidewalk into the road, but it is not designed to protect pedestrians from an errant vehicle. The pedestrian rail should be designed to discourage climbing, such a metal rail with a non-climb vinyl coated chain link fence.
